REVISED GEOTECHNICAL
ENGINEERING INVESTIGATION
REPORT

Reference: **Geotechnical Engineering Investigation Report, The Mosaic Project**
 17015 Cull Canyon Road
 Castro Valley, Alameda County, California

GEOTECHNICAL ENGINEERING INVESTIGATION REPORT
THE MOSAIC PROJECT
17015 CULL CANYON ROAD
CASTRO VALLEY, CALIFORNIA

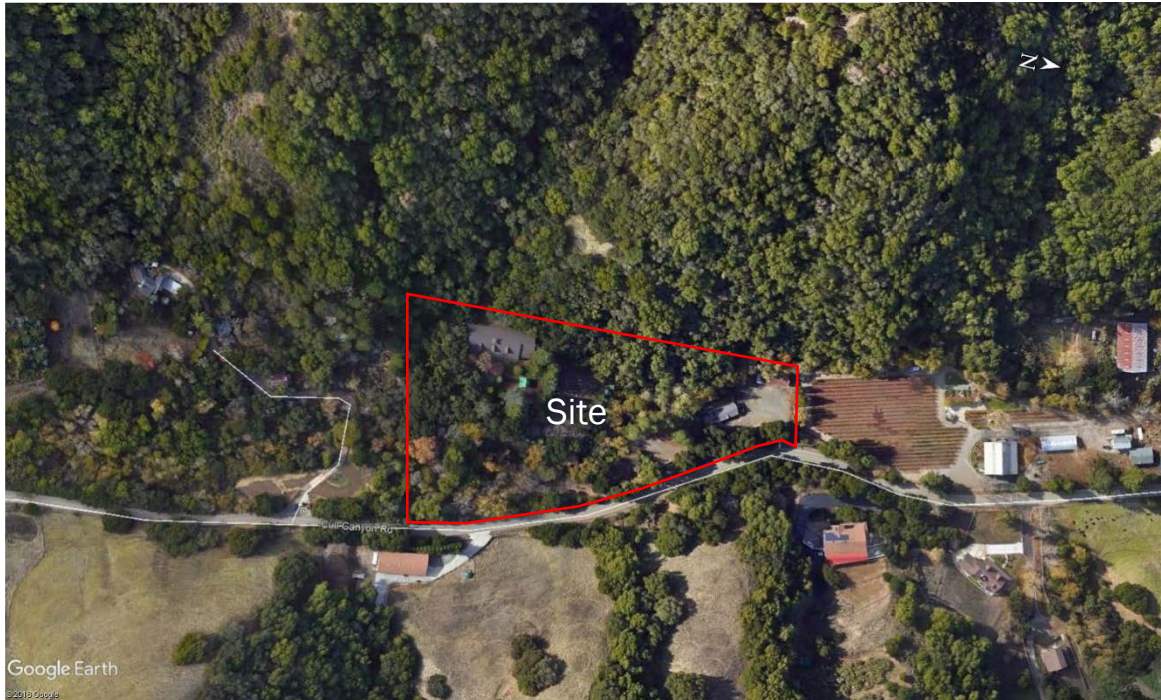
PROJ NO.: 70852.00
 DATE: AUGUST, 2019
 FIGURE NO.: **1**

SITE LOCATION MAP
 THE MOSAIC PROJECT
 CASTRO VALLEY, ALAMEDA COUNTY, CALIFORNIA

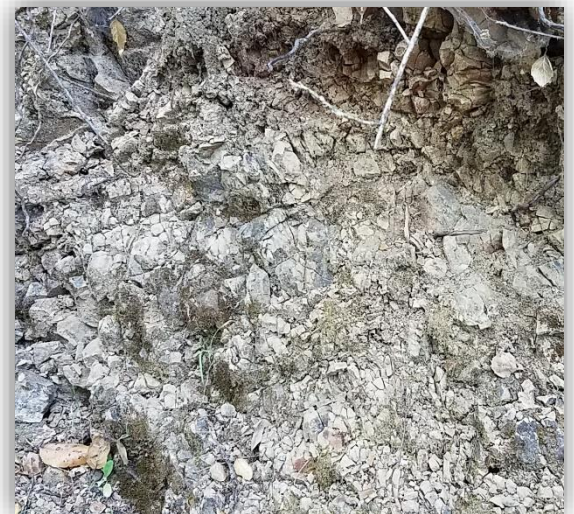
The Holocene alluvial deposits generally consist of unweathered gravel, sand and silt deposited by present-day stream channels during the Holocene Epoch (approximately 11,700 years before present to present-day).

The Monterey Formation is characterized as marine clastic and biogenic sedimentary rock generally consisting of clay shale or claystone and siltstone and siliceous shale that is thin bedded to bedded formed during the middle to late Miocene Epoch (16 to 5 million years before present [mybp]).
